Renovation of the Ten Sleep Hatchery, Wyoming

Steve Sharon, Fish Culture Supervisor
Bart Burningham, Ten Sleep Hatchery Superintendent
2011 Northwest Fish Culture Conference, Victoria
Wednesday, December 7, 2011

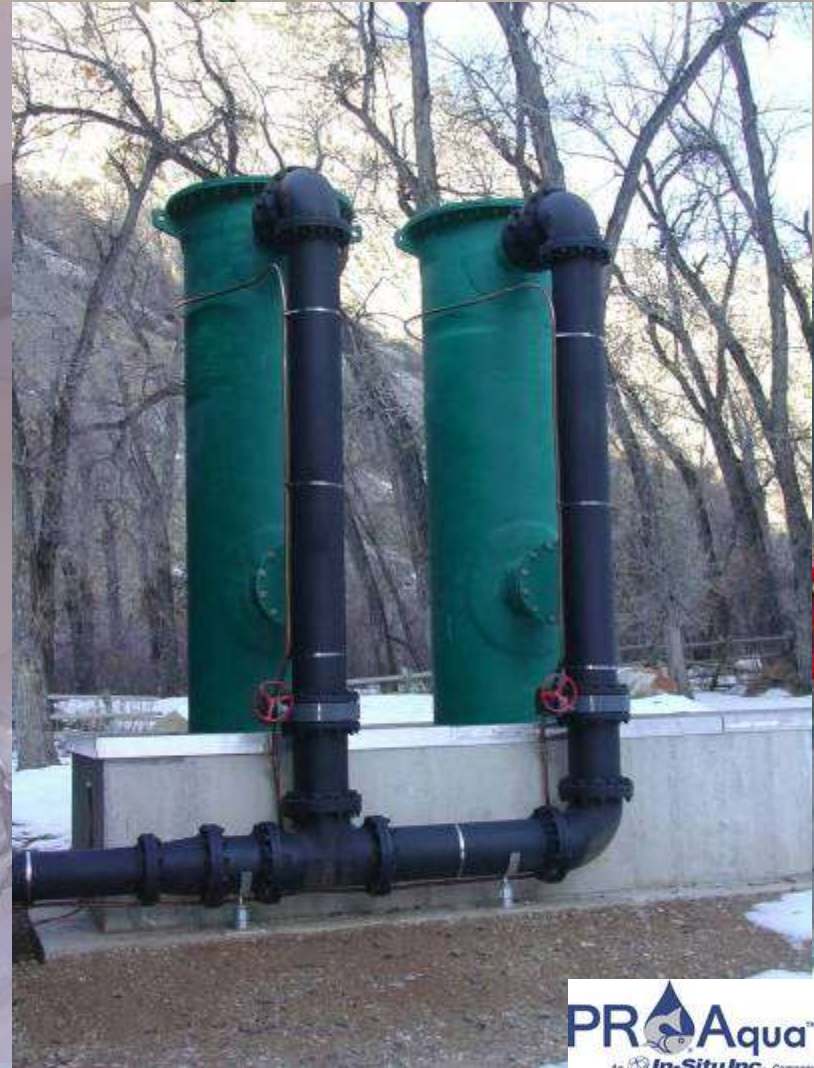
RFUV Duplex Disinfection

- One weir for RF & UV
- 50% flow through split to each unit
- Normal operation - Extended Exposure
- If RF or UV fails on one unit - Automatically transfers to other unit
- If both fail - Supply automatically bypasses small fish production.

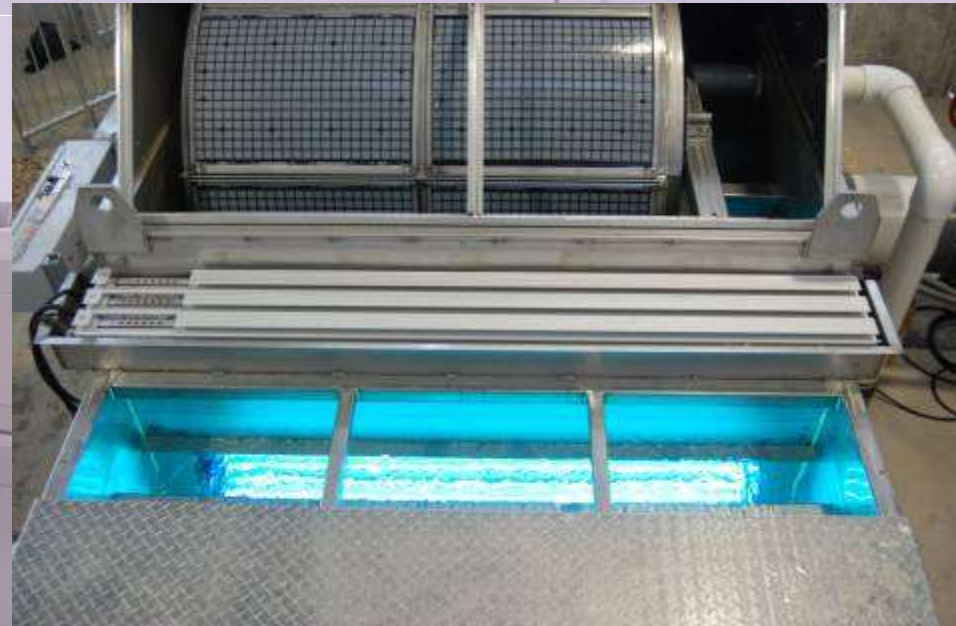
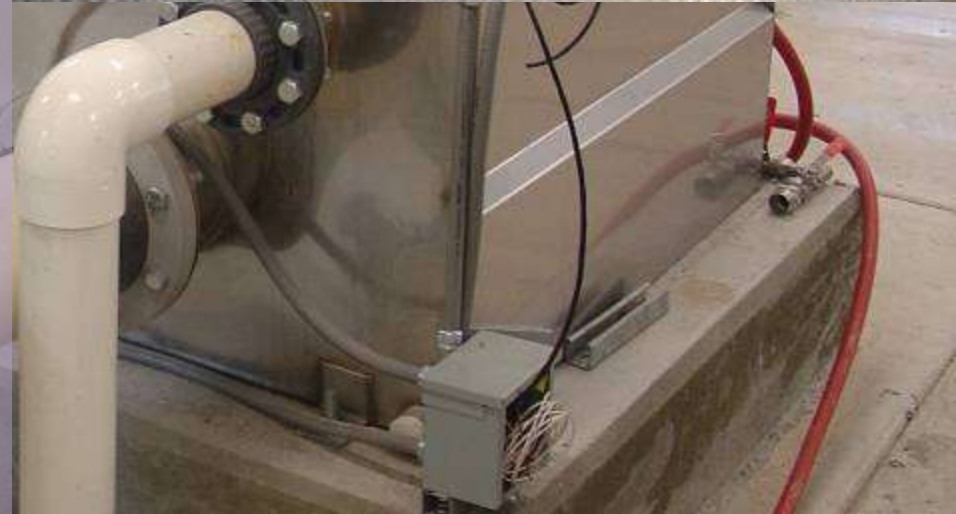
RFUV Duplex Disinfection

Cold Spring Supply

Warm Spring Supply

Water Treatment/Mixing Vault
